### Making Tailings Lagoons in Critical Condition Safer

Richard S. Goodwin FREng Chairman – Goodwin International Ltd, England rsgoodwin@goodwingroup.com

Making Tailings Lagoons in Critical Condition Safer

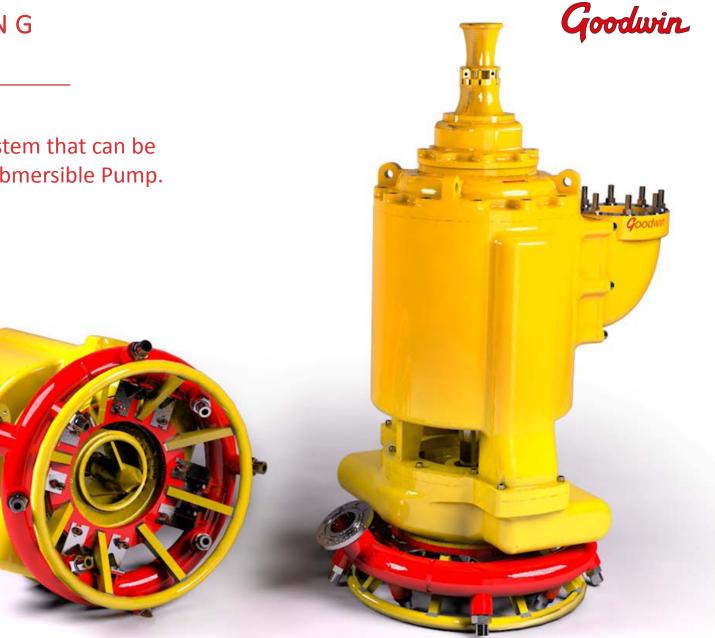
### **GOODWIN PUMP JETTING RING** High Performance for Critical Applications

Goodwin has precision engineered a jetting ring system that can be attached on to the base of a Goodwin 200 ANZE Submersible Pump.

The jetting ring acts to disturb and reactivate settled solids to enable the material to be transferred through the pump.

The high powered jetting action created by the jetting ring can be utilised to erode tailings and assist the central agitator, so slurries with high percentage solids content are pumped.

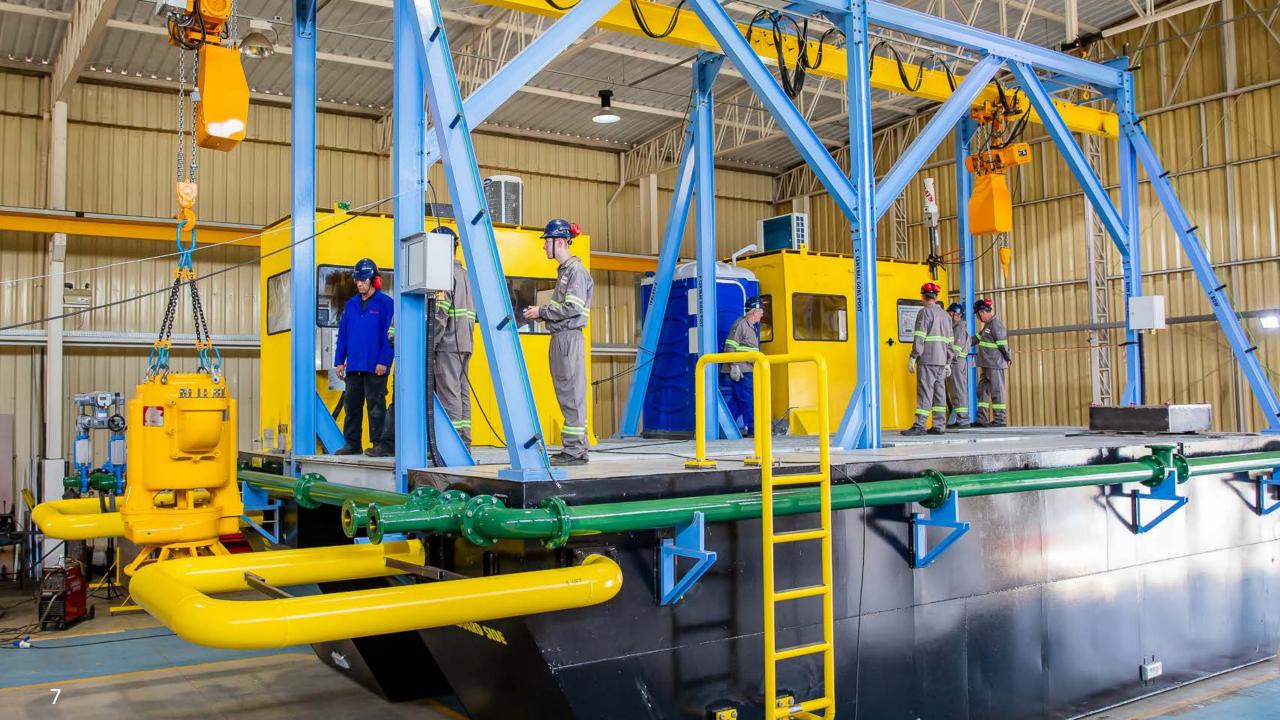
## This excavation was achieved using a just one Goodwin 200 ANZE Pump in **one calendar week**

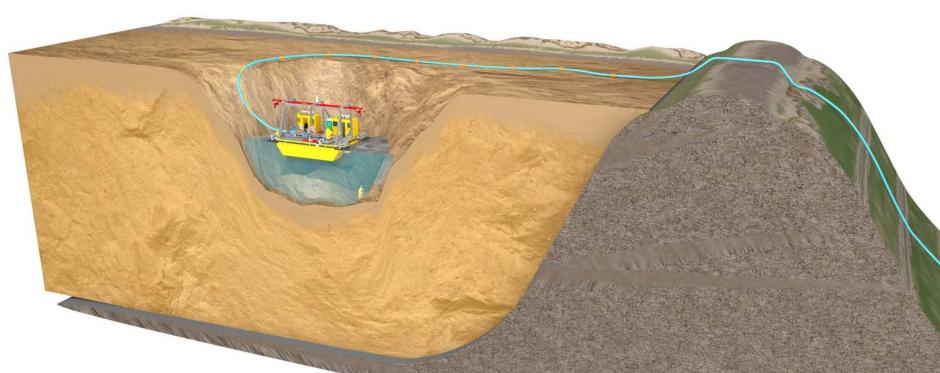
Once the excavation of the two conical holes had been completed, the Pontoon and Submersible Pumps will be used to pump any water that permeates into the holes down flexible pipes over the dam wall to the downstream side of the dam.

If this runs 24 hours per day then dewatering of the dam in the most critical areas would be very much improved. Also, when rain water flows down the lagoon towards the dam it would naturally migrate via the two trenches to the two 30 meter diameter holes so that it can be pumped away. This process is designed to keep the water table in the tailings lagoon near the dam wall between 10 and 20 meters below where it would naturally be.

This will prevent fluidisation of tailings material near the dam and also assist in preventing the fluidisation of the dam itself especially in the rainy season when rain flows down the lagoon and sits along the dam wall.

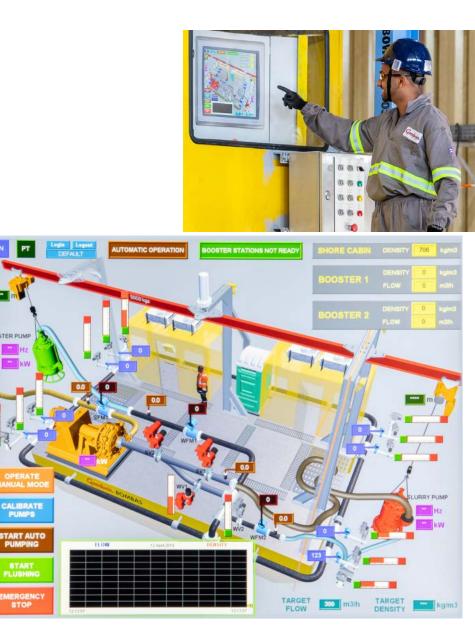
Goodwin Pontoons and Submersible Slurry Pumps can be controlled remotely, meaning that there is no need to send personnel into a potentially at risk Tailings Lagoon.

Goodwin provide control systems and panels for the operation of two Goodwin 200mm ANZE Submersible Pumps. These systems offer touch screen capabilities with intelligent software to control flow and measure density to ensure a pumping system will run efficiently without problems over a long period of time. There is dual control, one in the pontoon control cabin and one in the land based control cabin and both have identical control capability of the pontoon pumping activities and movement of the pontoon.

Pontoon movement and pump operation can be controlled remotely via a HMI screen in the shore based control cabin which transmits to the Pontoon using an industrial strength self tracking Wi-Fi signal. CCTV video on the pontoon and surroundings is also transmitted via Wi Fi to the land based control cabin TV.

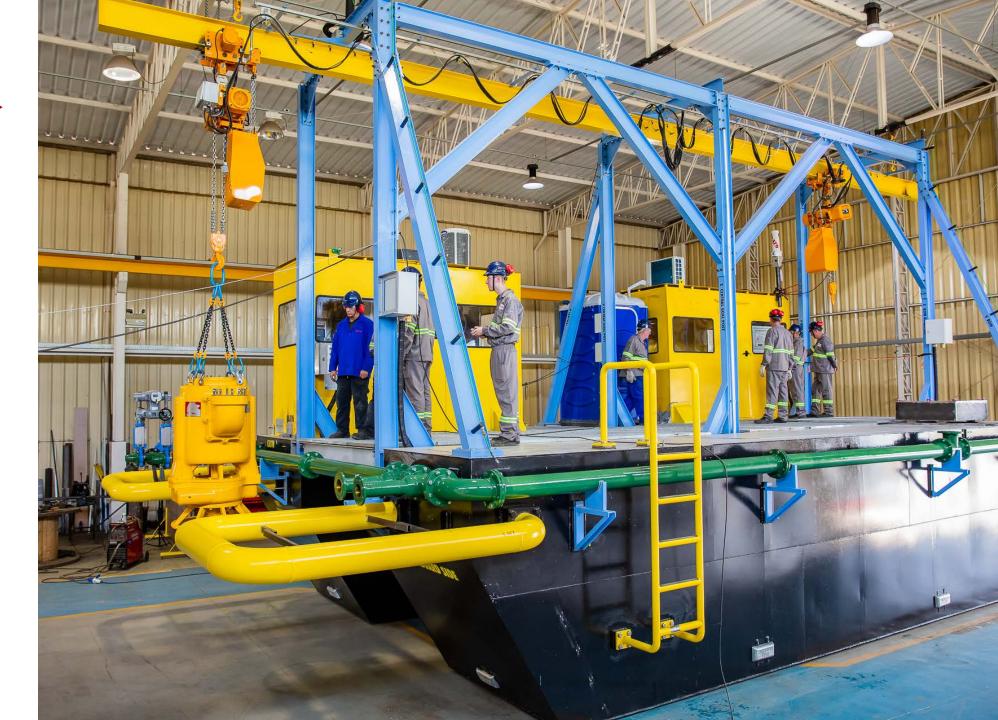
### G O O D W I N PUMP PONTOON

Goodwin Submersible Pump Pontoons are built by the pump and marine technicians within our Sao Paulo Brasil facility.

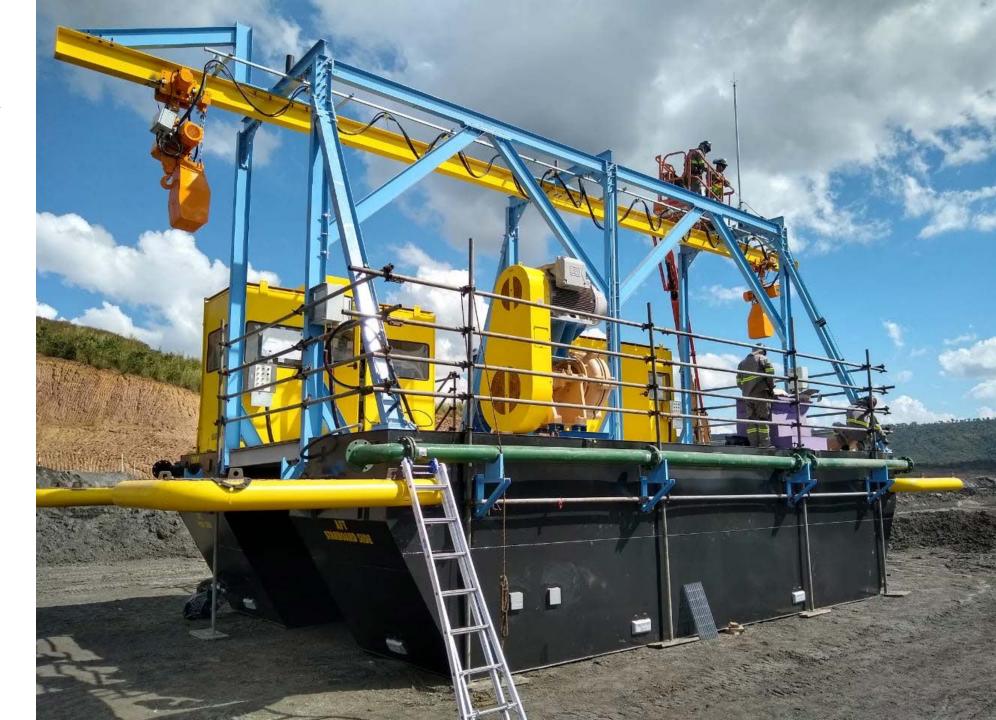
### G O O D W I N PUMP PONTOON

Goodwin Submersible Pump Pontoon assembled on-site in a ready excavated tailings lagoon.

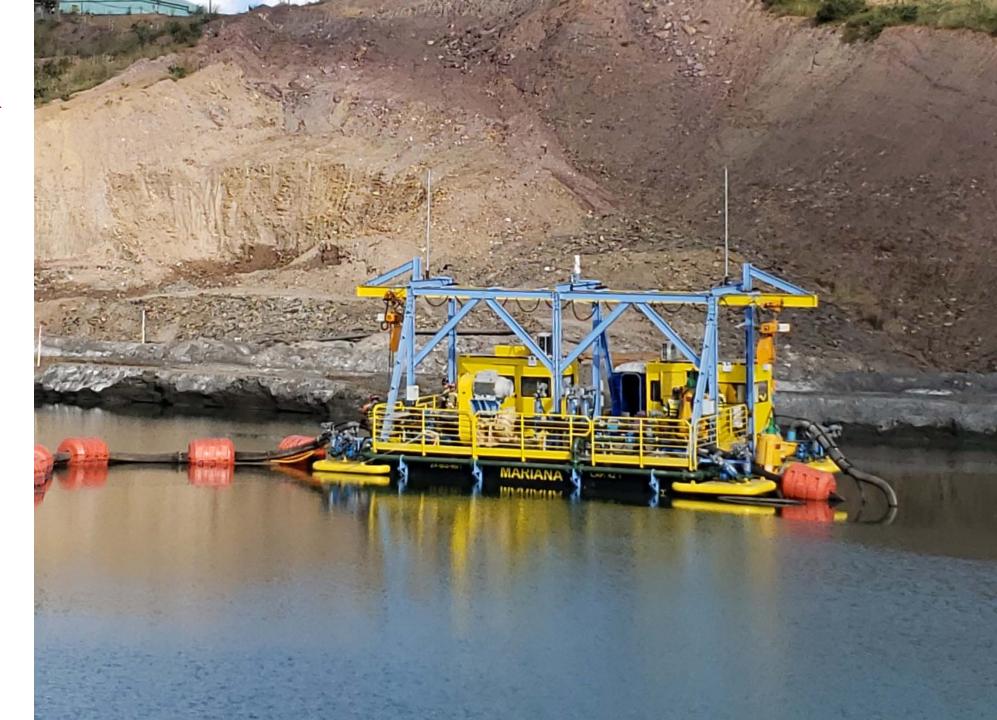
#### O O D W I N G PUMP PONTOON

Goodwin Submersible Pump Pontoon fully assembled, afloat and ready for operation in a water filled excavated hole in a tailings lagoon.
